9/11 Search for Truth: The World Trade Center (WTC)
Presentation at the Maine Common Ground Fair, 2017 & 2018 — Dick Atlee

(Note: this outline represents only the tip of the evidentiary iceberg, and ignores WTC buildings 3, 4, & 5)

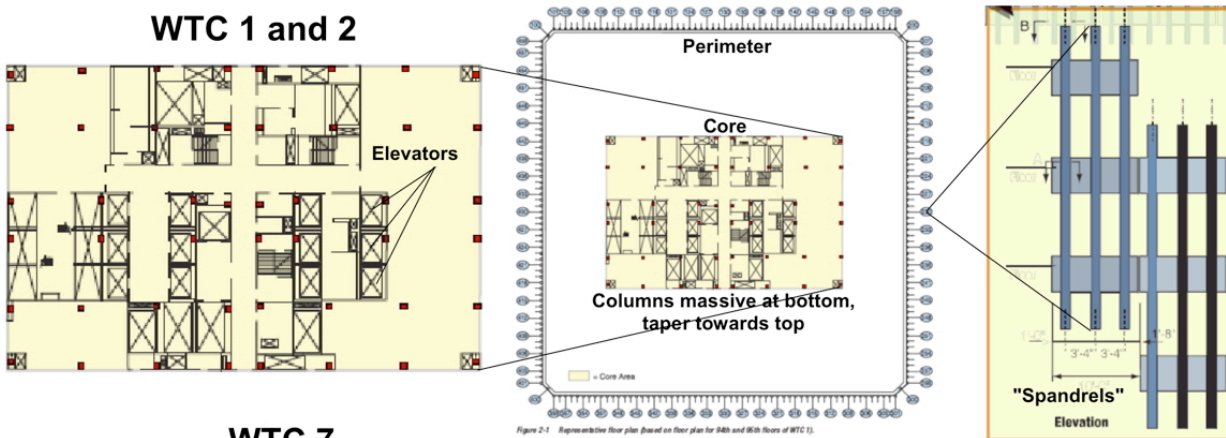
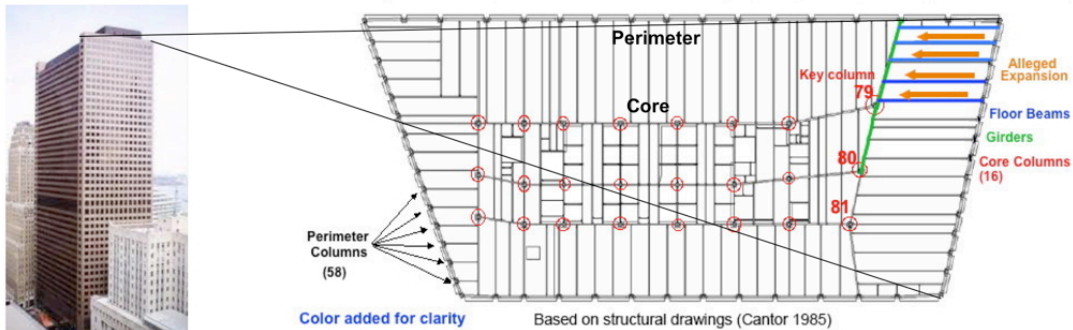
Figure 1: WTC Layout and Structure

- The first pair of images indicate the relative positions and sizes of the seven WTC buildings.
- The Twin Towers and Building 7 were both based on a very heavy, solid set of core columns connected to peripheral columns by floor-supporting members.

- In the Twin Towers, the peripheral columns consisted of alternating 30-foot 3-piece powerful steel units that created a mesh like a screen, with no fault running continuously along any one floor. The connection to the core was via zig-zag floor trusses which allegedly sagged, despite their fire-proofing.

- WTC 7's core was connected to the periphery by I-beams (blue, above), which allegedly expanded, pushing their girder (green) to the left and off its seat on the column it was supporting – column 79.

- The main problems with this were (a) the absence of a source of expansion-generating heat, (b) the omission of shear studs on the beams and girder which would have prohibited expansion/shifting, and (c) the omission of the steel plates whose purpose was specifically to prevent a girder's shift off its seat.

1. 47-story, core & perimeter columns, columns/girders/floor-beams
 2. Secure: held many government agencies: CIA, FBI, SEC, NYC's EOC
 3. Fell late in day (5:20pm) after several premature collapse assertions in news
 4. Large explosions in early morning and just before collapse
 5. Larry Silverstein's "pull" comment, *not* (as claimed) about removing firefighters
- b. NIST Report – problems
1. Quick description of NIST explanation:
fire -> beam thermal expansion -> push girder off column 79 -> column collapses

1. Core & perimeter columns, floor trusses connect core to perimeter
 2. Structure designed to withstand 707 airliner, like poking pencil through a screen

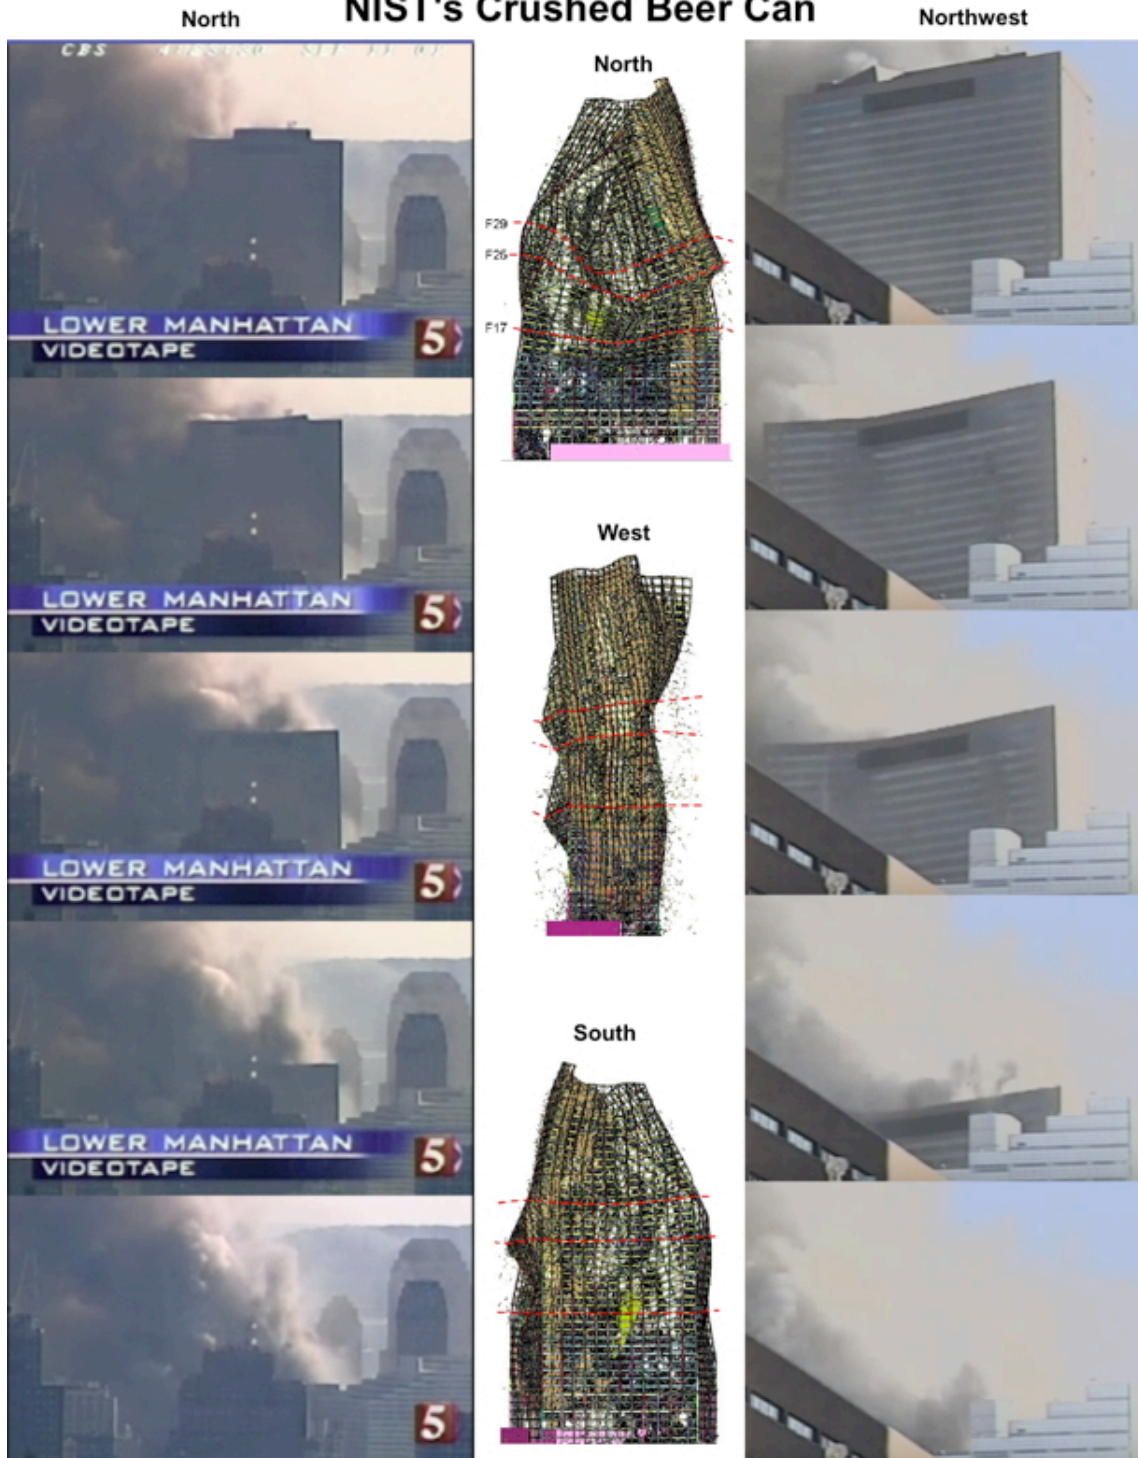
Figure 4: WTC7 Actual Descent vs NIST's Crushed Beer Can

- These stills from videos taken from the North and Northwest show the top of the building descending intact, almost as if it were being sucked into the ground. The only visible deformations are a single vertical crease in the North wall that develops just as descent commences, and a tilt to the Southwest as the building is disappearing from sight (better visible in other videos).
- NIST's model, on the other hand, shows a process that looks more like twisting and crushing a beer can. NIST only pursued the process for the first couple of seconds. You have to wonder how expert scientists can present this obvious divergence from reality with a straight face.

2. "Progressive collapse" twisted-beer-can diagram bears no relation to videos
 3. 2.5sec/8-floor freefall covered up by NIST, denied, then admitted but not acknowledged
 4. Claim of heat-induced beam expansion found to be fraudulent
 - a. False and changing "clerical error" measurements
 - b. Omitted from model: shear studs lock beams to flooring (prevent expansion)
 - c. Omitted from model: girder support flanges at column (prevent girder falling)
 - d. Fire had gone out in alleged key area long before collapse
- c. AE911Truth-sponsored complete technical re-analysis concludes fire couldn't have done it — preliminary report: <https://www.youtube.com/watch?v=RYV33LKDY8k> (9/6/17)

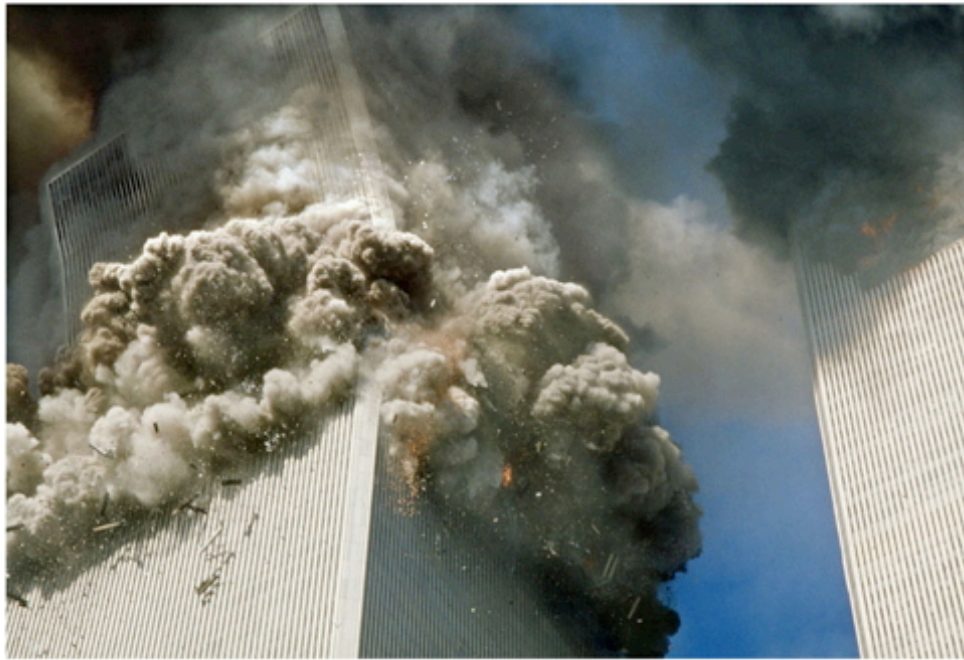
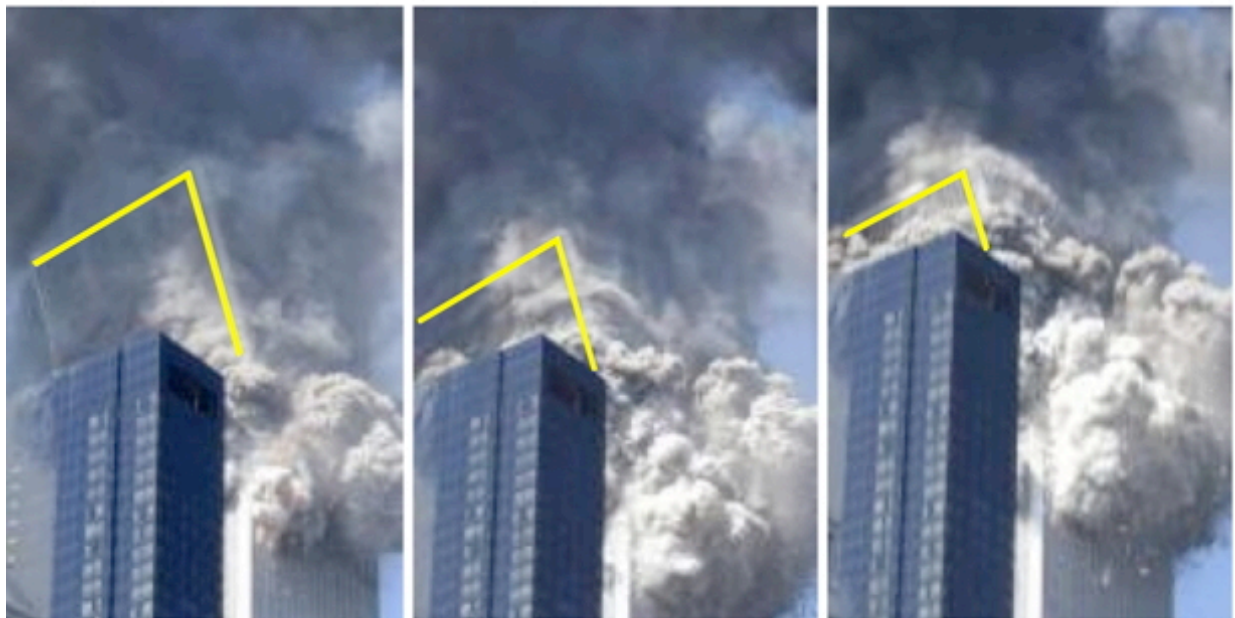
**Figure 5: WTC2 Top Tips, Tilts, Stops . . .
and Disappears**

- Angular momentum – once an object starts rotating, it will continue to rotate unless an external force acts on it.
- Here, the top section – the alleged "pile driver" – starts to rotate, but then inexplicably stops rotating and appears to descend, or at least its roofline descends.
- But note that the visible undestroyed corner of the lower section of the building stays in approximately the same position during this "descent." This means that the "pile driver" is not descending and crushing the section below, but is actually being destroyed in midair.
- This conclusion is supported by the absence of large pieces of the top section in the debris pile. There's just a wider distribution of deconstructed debris on that side of the building's footprint (see Figure 3).

- b. WTC2 tilted top stops tilting, vanishes in dust, not on ground afterwards
- see FIGURE 5: WTC2 block tilts, tips, stops, disappears**
- e. Large pieces of non-spring structural steel thrown up to 200 yards at up to 100 mph
