NIST NCSTAR 1-1 (Draft)

**Federal Building and Fire Safety Investigation of the
World Trade Center Disaster**

**Design, Construction, and
Maintenance of Structural and Life
Safety Systems (Draft)**

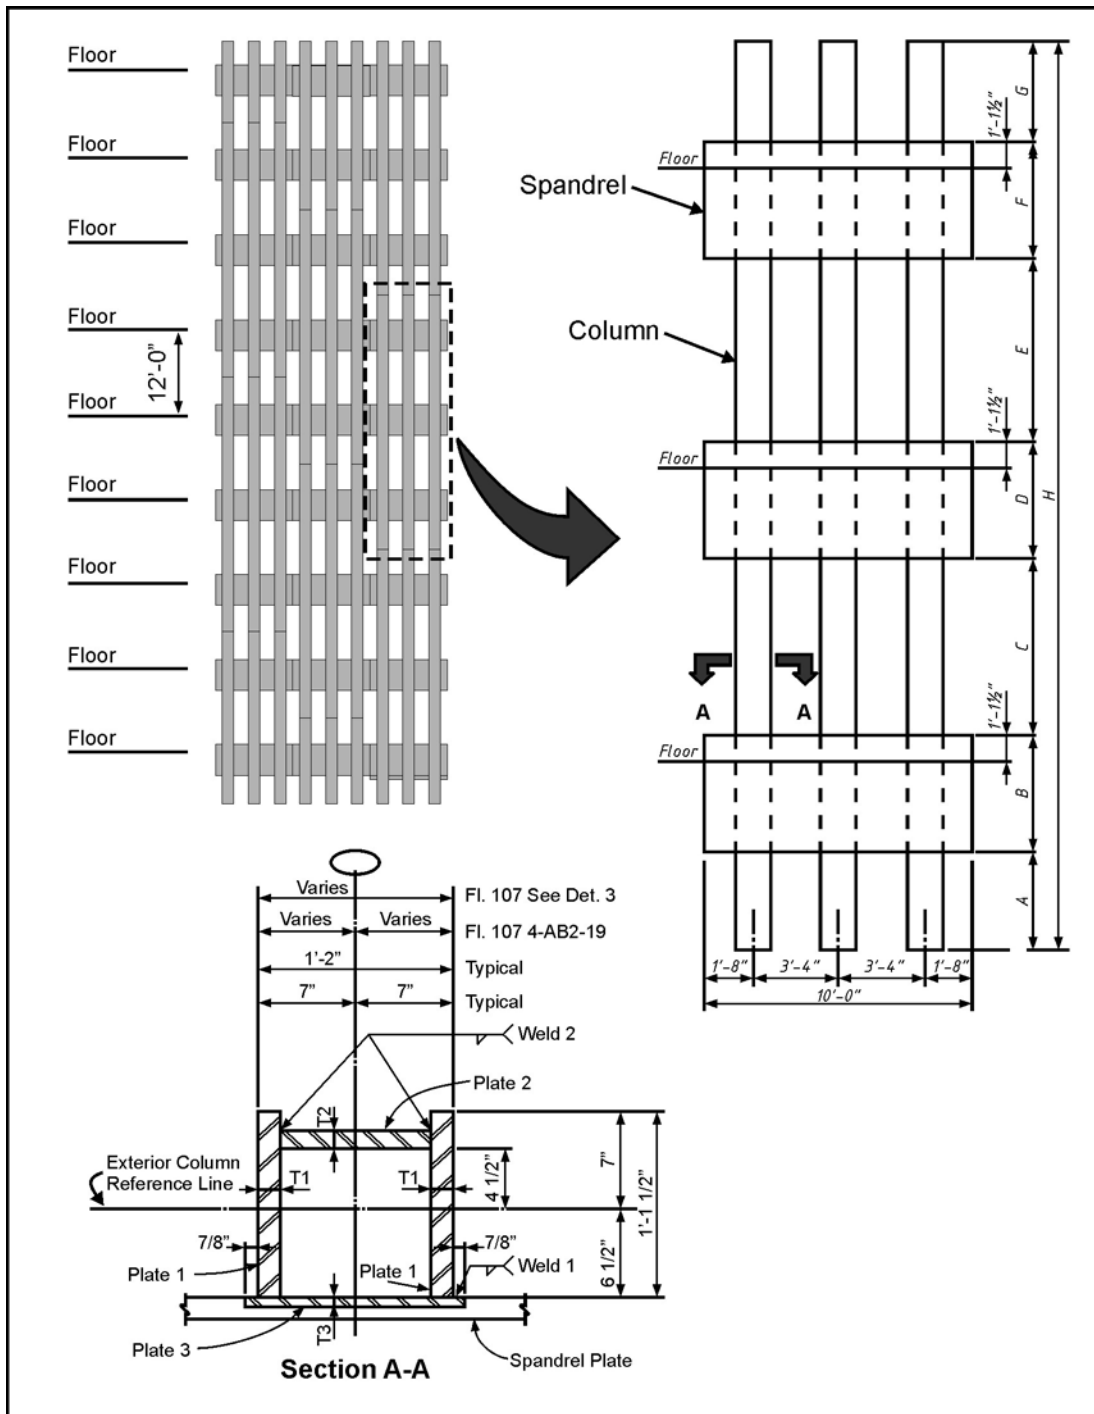
Figure 2-9. Typical WTC tower exterior wall panel.

Each tower had a square plan with the side dimension of approximately 207 ft. The exterior columns (perimeter columns) were placed with respect to the column reference lines, wherein the geometric centers of the exterior columns were offset from the column reference lines (See Sec. A-A, Fig. 2-9). The four reference lines surrounding the base of the tower established the footprint of the building. The column reference lines were spaced at 207 ft 2 in. The corners of the tower were chamfered 6 ft 11 in.

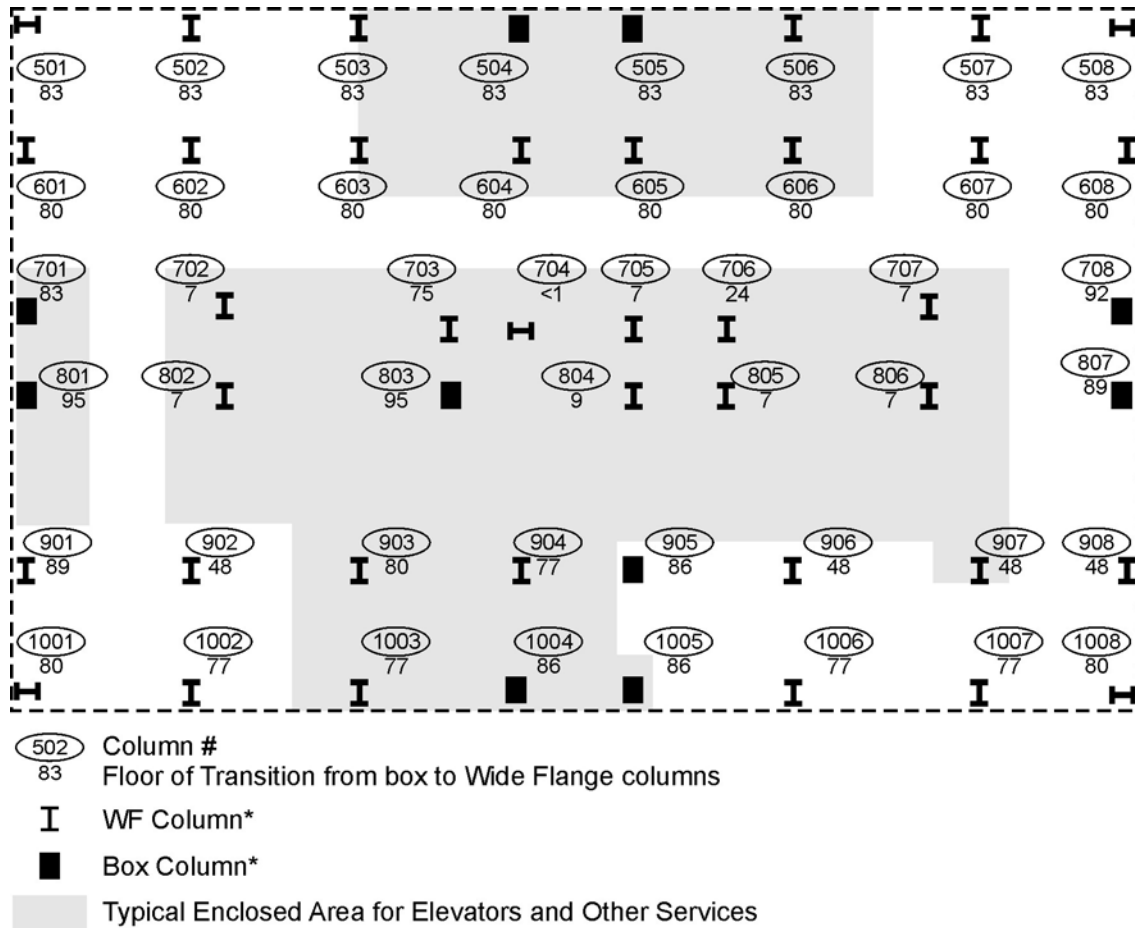
*Shape of Column at the 84th Floor

Figure 2-12. Core column layout in WTC towers.

The core columns were of two types: welded box columns for the lower floors and rolled wide flange shapes for the upper floors. They were designed to support about 50 percent of gravity loads. Below floor 7 to the foundation, where there were fewer perimeter columns in the outer walls, bracings were used in the outer perimeter of the core area to increase lateral stiffness. In the lower part of the towers, the outer core columns were designed to resist a portion of the lateral forces. Hidden within the building, the core columns were thicker and larger on the lower floors. Thus, core columns used fewer grades of steel. The box columns were either 36 ksi or 42 ksi. Core wide flange columns were one of four grades, yield strengths ranging from 36 ksi to 50 ksi, but most (approximately 90 percent) were primarily 36 ksi or 42 ksi steel.

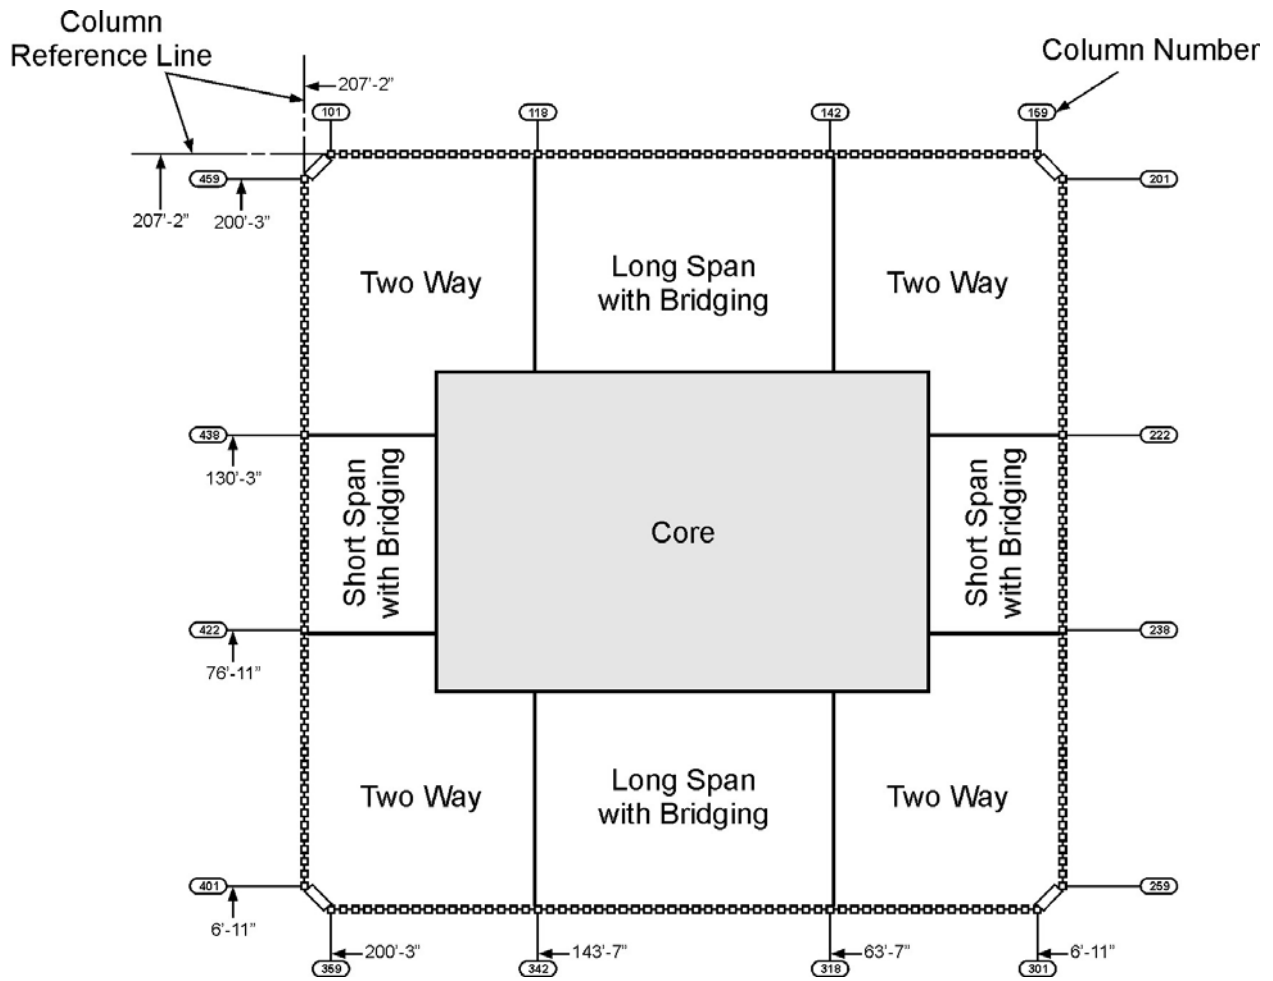
Figure 2-15. Typical WTC floor truss framing zone.

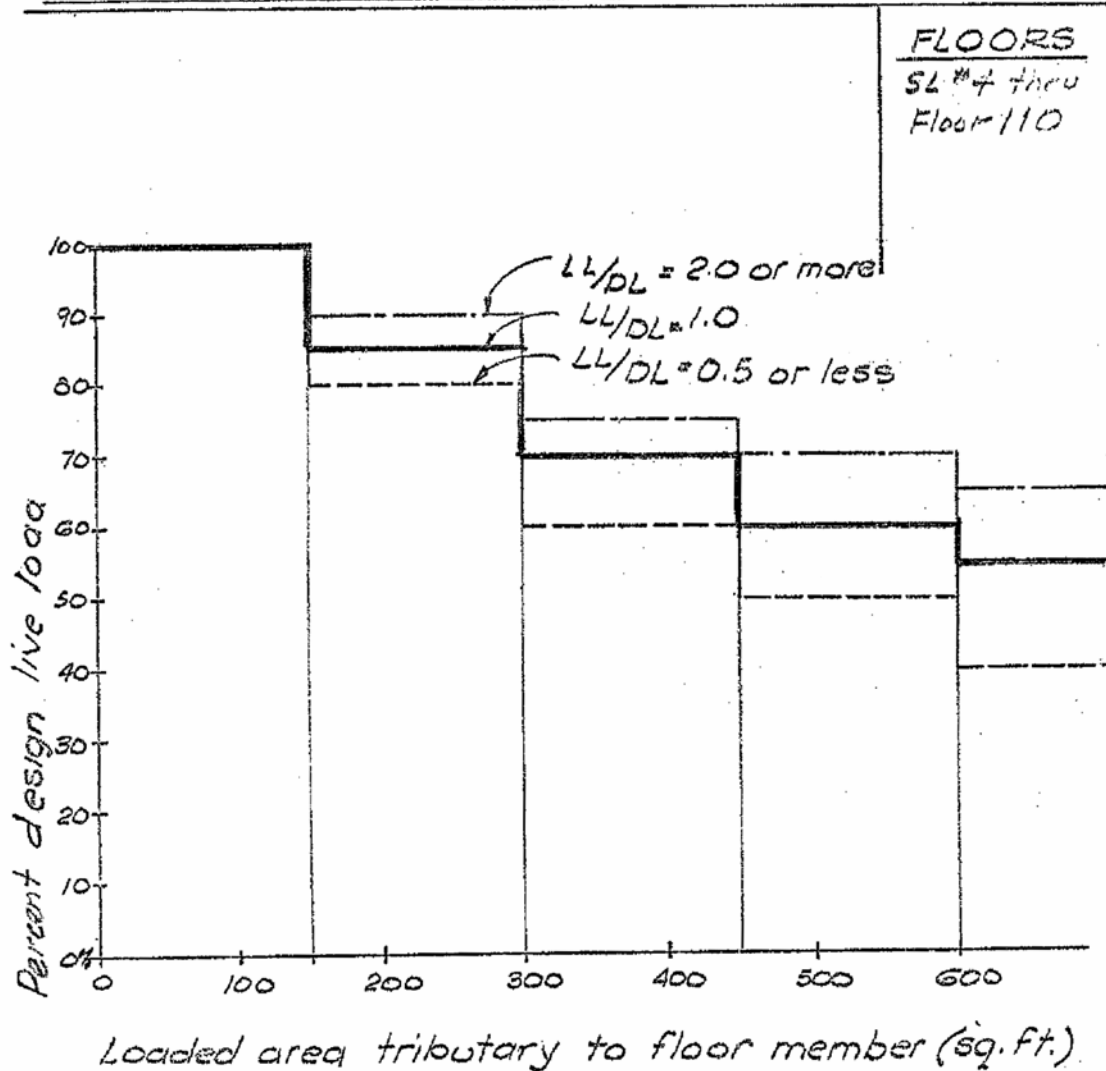
CRITERIA FOR DESIGN - DESIGN LOAD
FLOOR INSIDE OF CORE
(EXCEPT TENANT AREAS)
LIVE LOAD REDUCTION

Figure 5-11. Live-load reduction criteria for floors inside of core, except for tenant areas.

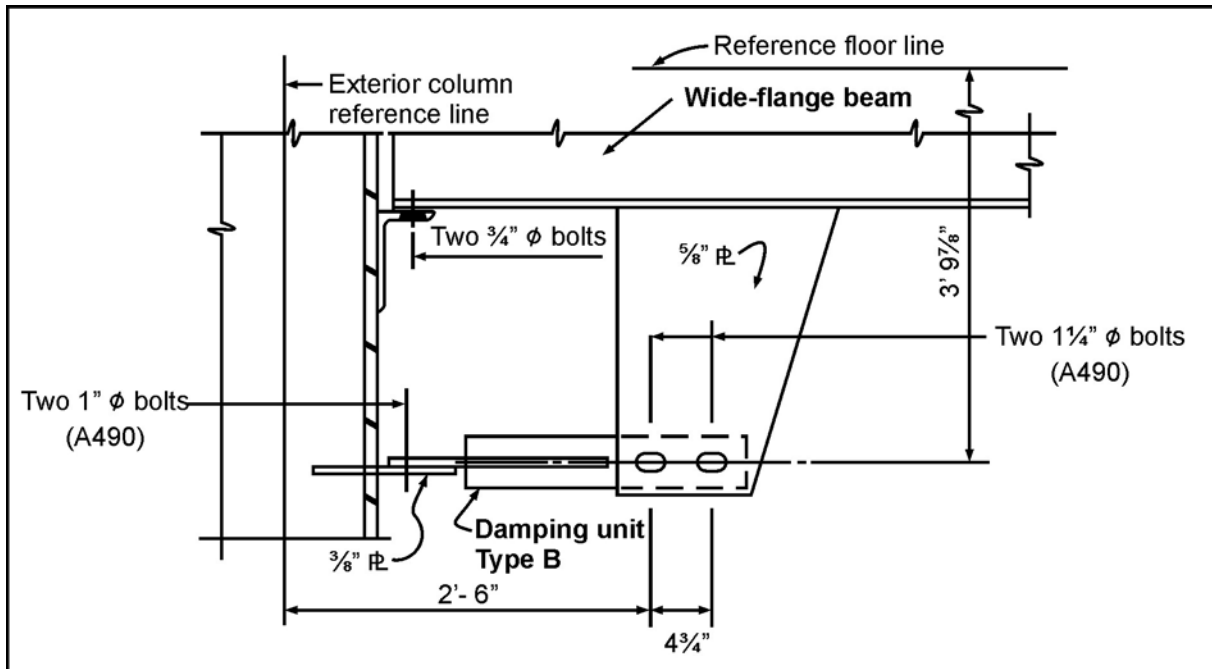
Figure 6–1. Wide-flange beam member with Type B damping unit.

floors 7, 9, 41, 43, 75, 77, and 107). This type of damping unit was located between the bottom flanges of the floor beams and the outside wall, as shown in Fig. 6–1. The use of dampers increased significantly the critical damping ratio of the towers. The reduction of oscillation during strong winds was estimated to be about 12 percent of the amplitudes without dampers. Expected time period during which building oscillation might be perceived by the occupants was estimated to be reduced by about 34 percent (SHCR 1967).

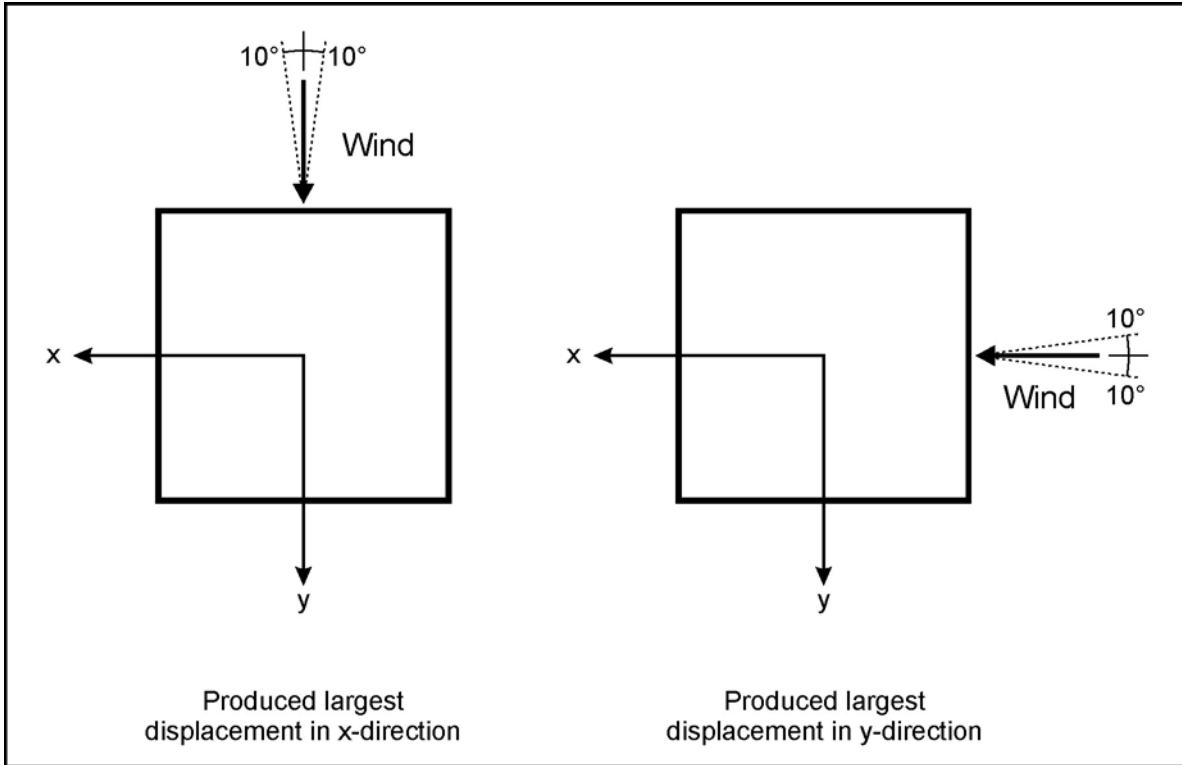
Figure 6–2. Wind directions that produced the greatest displacements at the top of the tower during the wind tunnel tests.

The tests also indicated that large lateral deflections at the top of the building occurred for wind velocities in the range of 125 mph to 130 mph for angles of incidence within approximately 10 degrees of normal (see Fig. 6–2). The results are plotted in Figs. 19 and 20 in WSHJ (1965c). The deflections showed a consistent dependence on the degree of damping and were shown to be inversely proportional to the damping ratio.

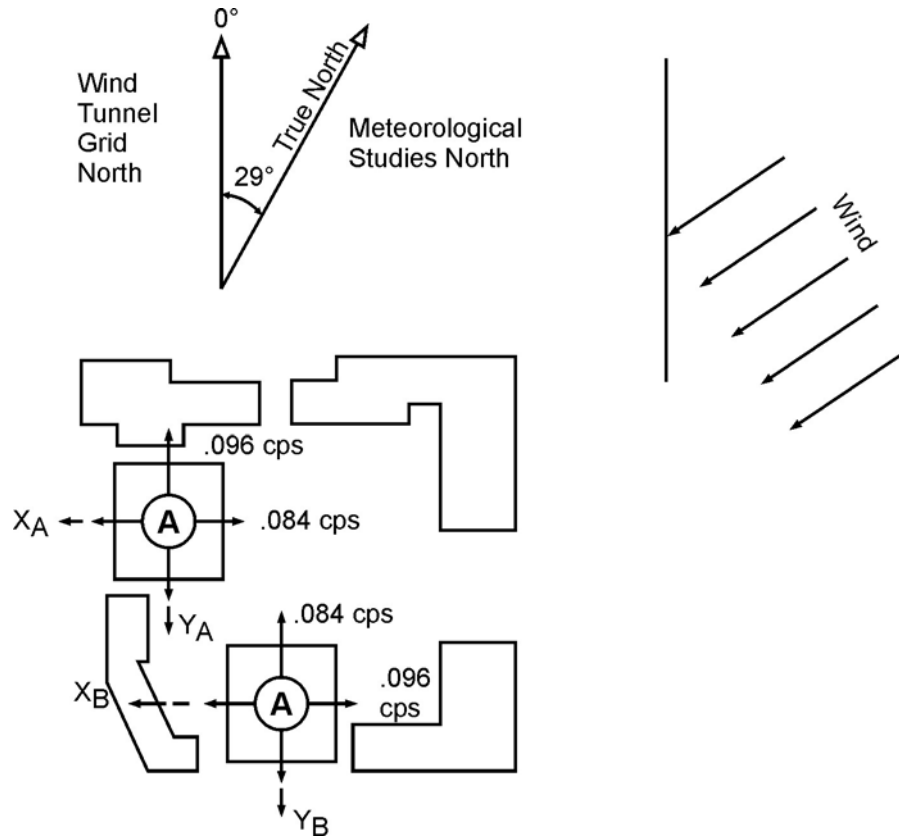
Figure 6–3. Definition of grid system and tower configurations for wind tunnel tests at Colorado State University.

Tests were also conducted at CSU using the southeast and southwest models of lower Manhattan subjected to turbulent flow conditions (WSHJ 1966c).³⁰ Both single-tower and twin-tower configurations were considered. Definition of the grid system and tower configurations used in the tests is illustrated in Fig. 6–3. Also shown in the figure are the experimentally determined fundamental frequencies of the towers in the two principal directions in cycles per second (cps). Included in these tests were measurements of the maximum deflections at the tops of the towers (aeroelastic tests; wood models) and pressures along the height of the towers (thermoplastic models).

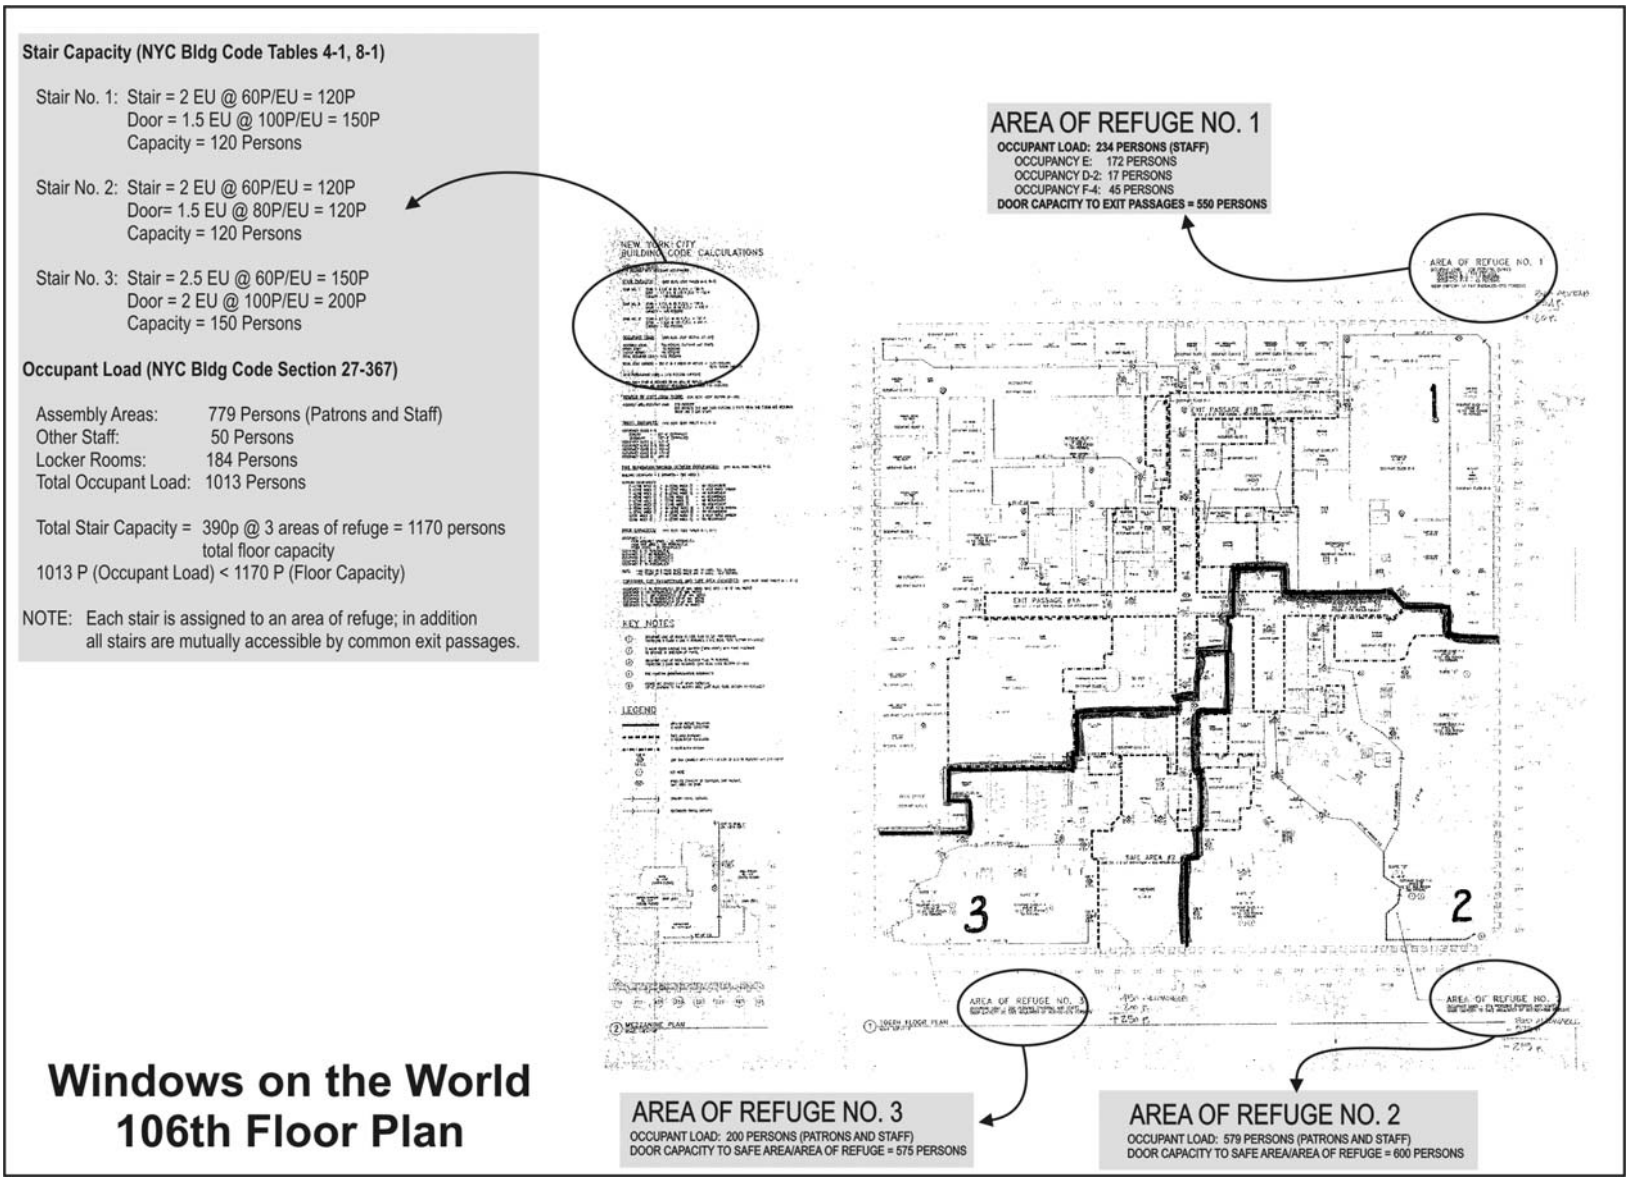
Figure 10–1. Arrangement of floor 106 egress.

Attached to (and referenced in) the letter were two plans entitled “106th Floor Egress Plan” and “107th Floor Egress Plan” that detailed the arrangement. The 2 h separation walls snaked across the floors and were not aligned on the two floors. Some areas that needed to remain open to free passage were protected with so-called Won-doors (accordion doors that are fire rated and are closed automatically on activation of the fire alarm system). Details of the egress system design calculations and corresponding NYC Building Code requirements are included on the plans to demonstrate that they met code requirements. Figures 10-1 and 10-2 are the actual attachments to the letter which included both diagrams of the arrangement of the rated partitions and the calculation of occupant loads for the 106th and 107th floors, respectively. Important details of the calculations have been enlarged by NIST.
